DYNAMIC RELATIVE BLADE PITCH MISALIGNMENT – SPREEWINDTAGE 2021

Introduction

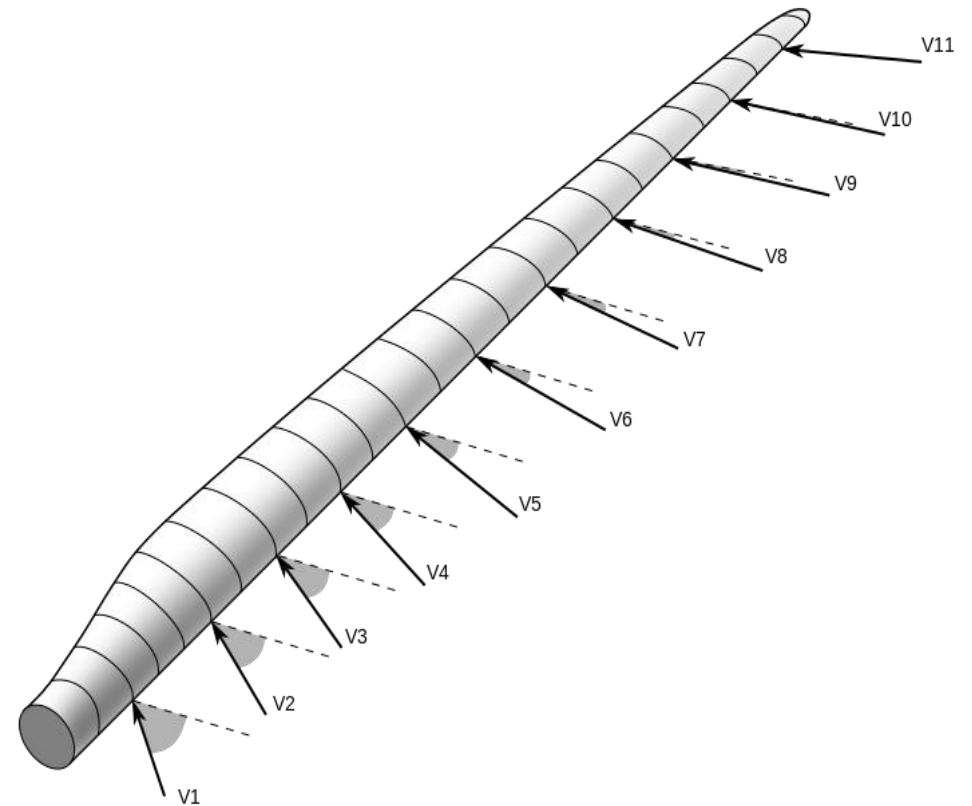
Fig. 1: Angle of attack of different sections of a wind turbine blade

- The blades of a wind turbine are designed to operate at the optimal angle of attack and same pitch angle
- During the blade installation, deviations from the optimal angle of attack can be introduced, due to mechanical tolerances, human errors etc. This in addition to problems in the pitch system (bearings, actuators etc) can lead to a significant level of relative blade pitch misalignment
- Two main consequences:
 - Reduction in the Annual Energy Production (AEP)
 - Increase of the fatigue in the different components of the wind turbine

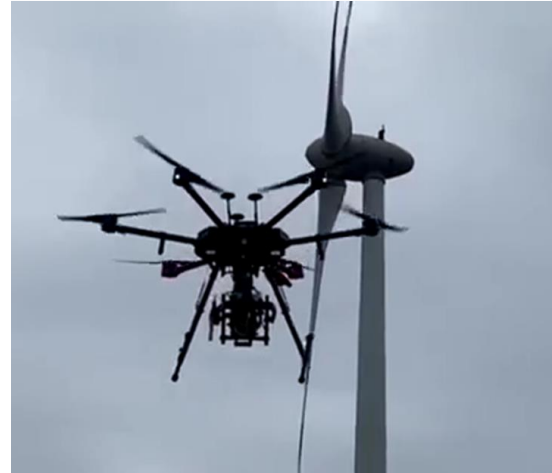
Img.2: Drone/UAV camera setup

- High speed camera setup configuration
- High performance laptop with installed image acquisition & image analysis software
- Camera carrier:
 - Tripod - Ground based setup
 - Drone - UAV setup

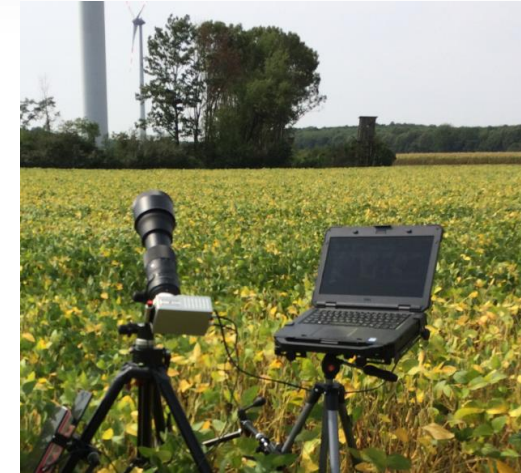
Img.3: Ground based setup

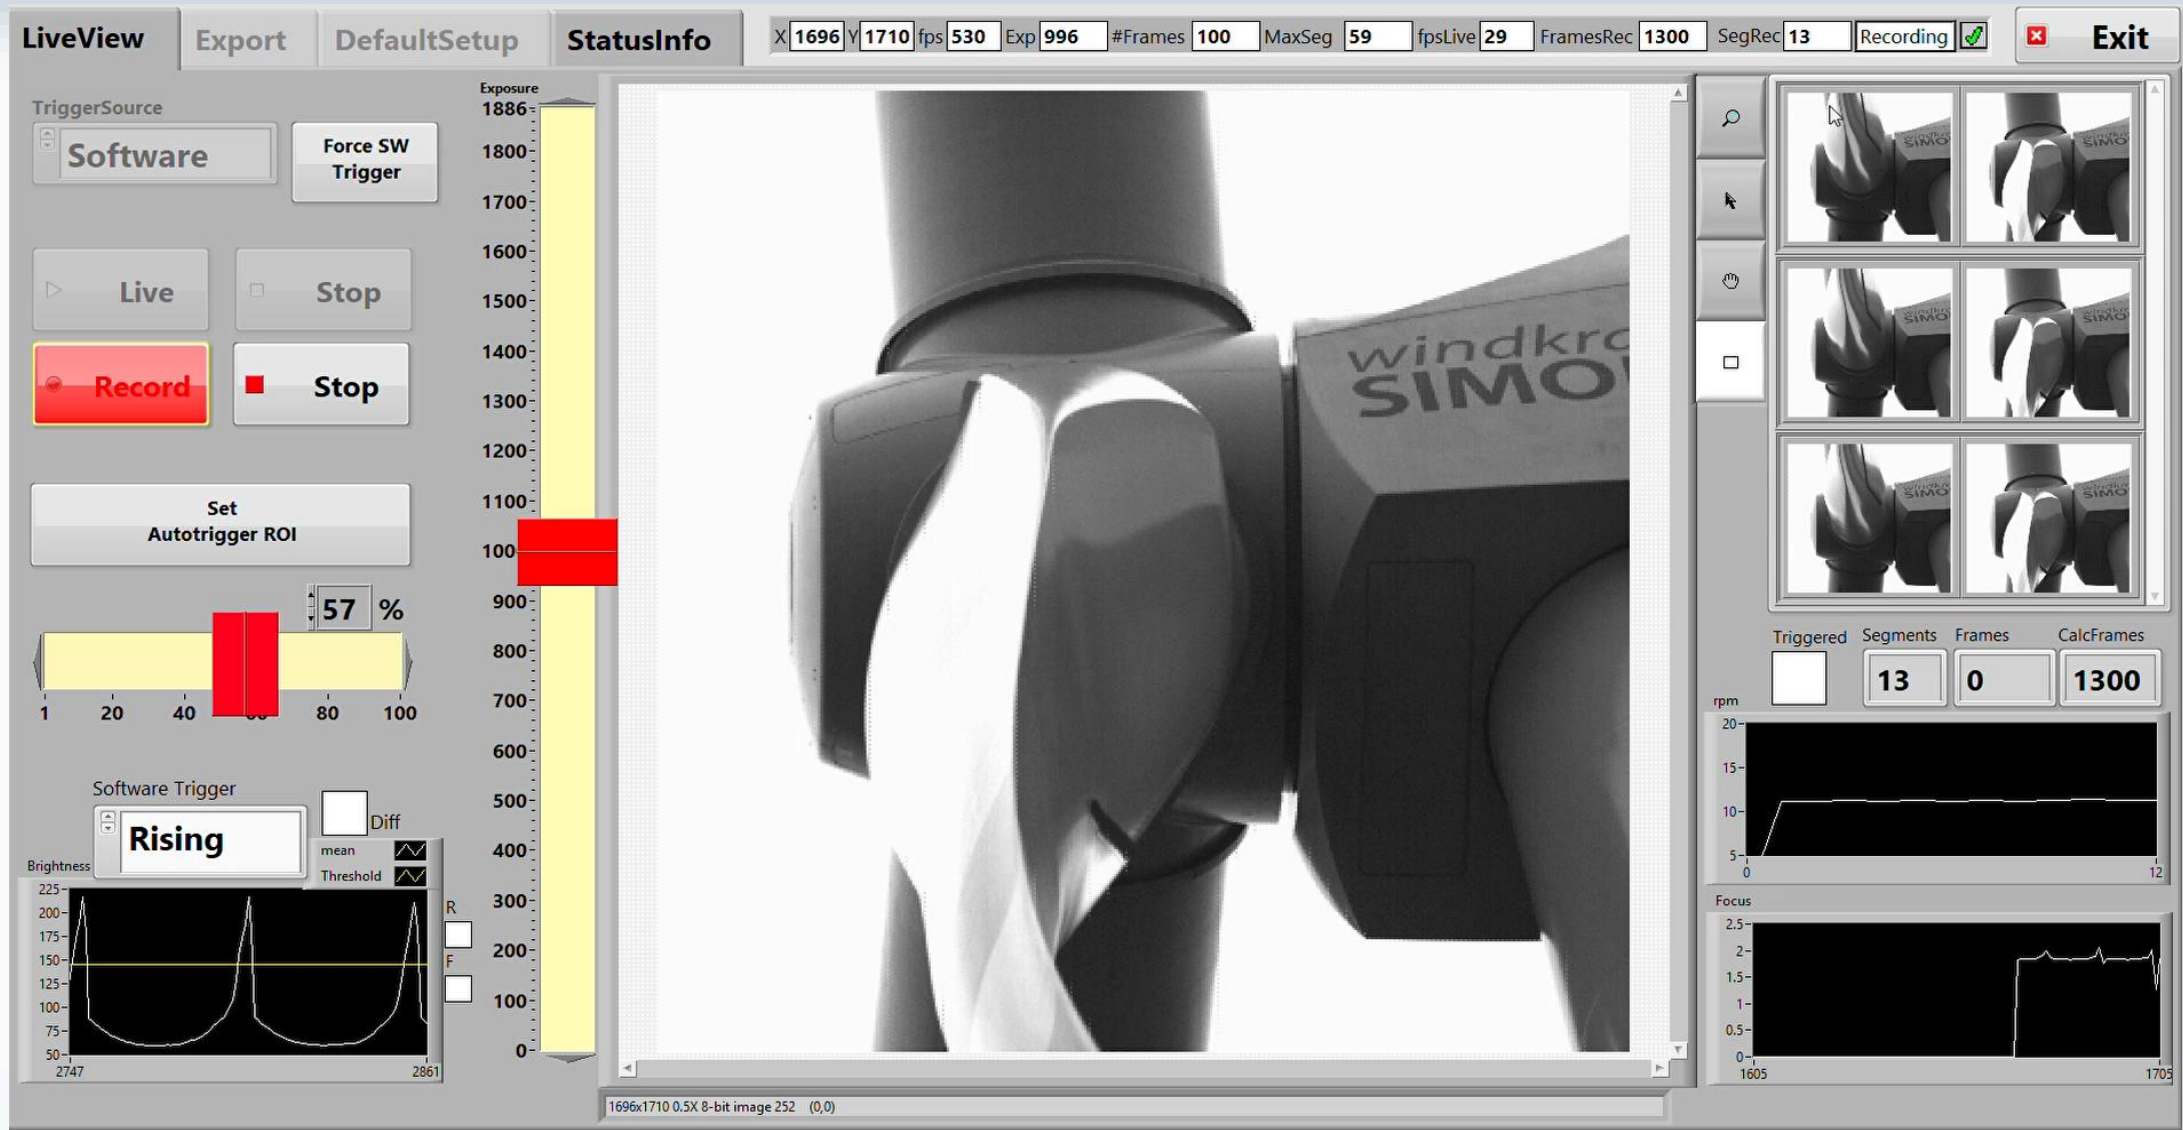
Image acquisition software example

LiveView | **Export** | **DefaultSetup** | **StatusInfo** | X: 1696 | Y: 1710 | fps: 530 | Exp: 996 | #Frames: 100 | MaxSeg: 59 | fpsLive: 29 | FramesRec: 1300 | SegRec: 13 | Recording: | **Exit**
